# Case Studies in Redesign

SOLVING PERFORMANCE PROBLEMS CAUSED BY  
MODIFICATIONS TO A PRODUCTION MODEL MAY CALL  
FOR ALTERATIONS TO THE ARCHITECTURE OF THE HULL

TEXT, PHOTOS, AND ILLUSTRATIONS BY ERIC W. SPONBERG

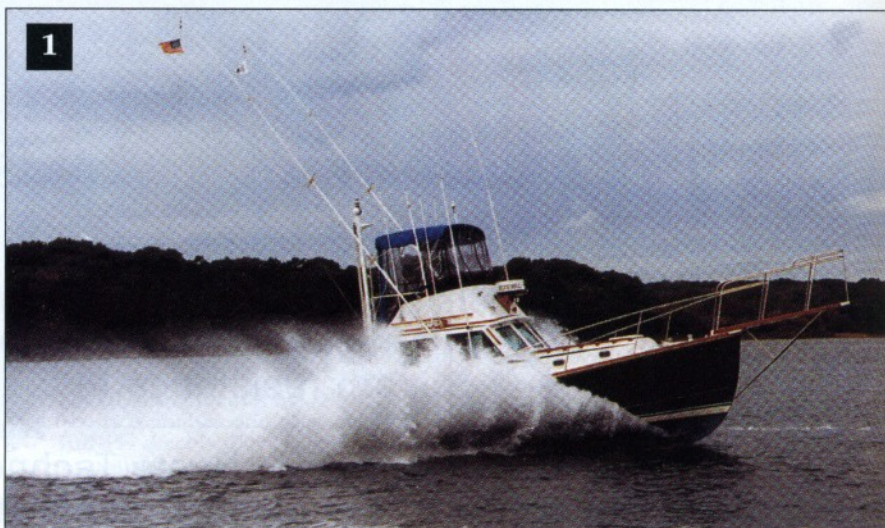
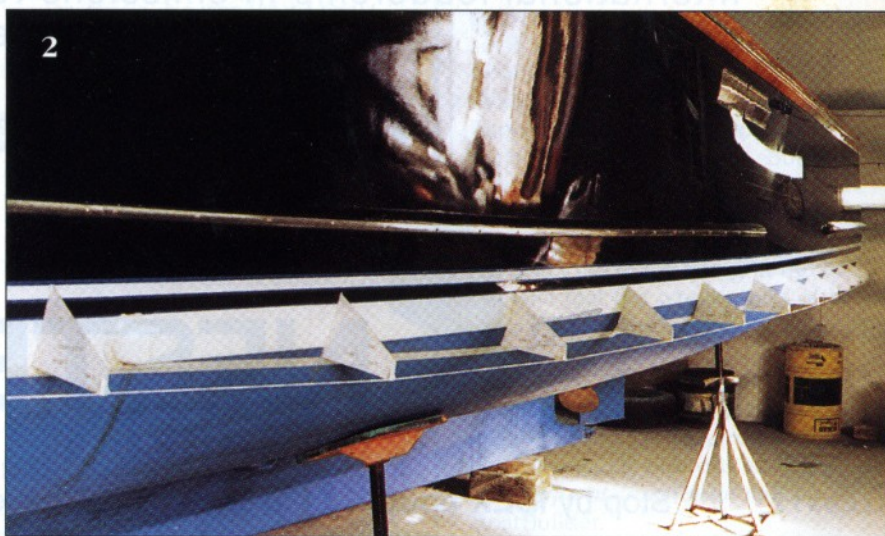
I felt that full-length lifting strakes would solve the problem. *Lifting strakes* are long, narrow shapes on boat bottoms that provide dynamic lift as well as deflect
